# **Facility Condition Assessment Reports**

**Facility:** \Abandoned\Pine Valley School  
**Address:** 16535 Hosston Rodessa Road, Rodessa, LA 71044**Attributes:**  
\*\*\*None\*\*\***General Information:**

<b>Function:</b>	Abandoned	<b>Year Built:</b>	1956
<b>Gross Area:</b>	30,802 S.F.	<b>Last Renovation:</b>

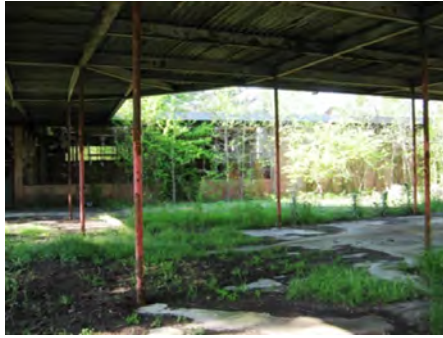
23-Apr-2010  
Covered Walkways

The covered walkways are constructed of steel columns, roof joists, and a metal deck which is covered with the remains of what appears to be built-up roof coverings. The walkways are damaged and deteriorated beyond economical repair. Demolition and removal of the walkways are needed and recommended.

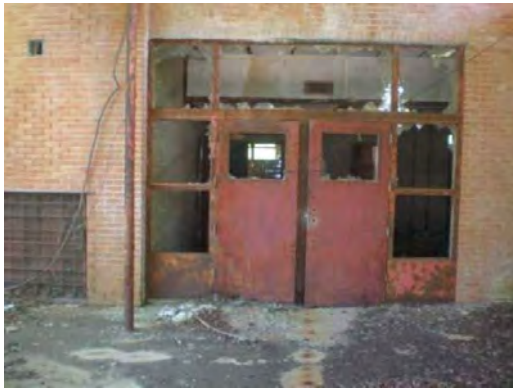
Note: **The building and site systems at the Pine Valley School are damaged and deteriorated beyond economical repair throughout. The building and site are unsafe and demolition and removal of the building and site systems are needed. Estimate includes demolition and removal of the building, pavements, and other site systems. Estimates for absestos testing and abatement are also included.**

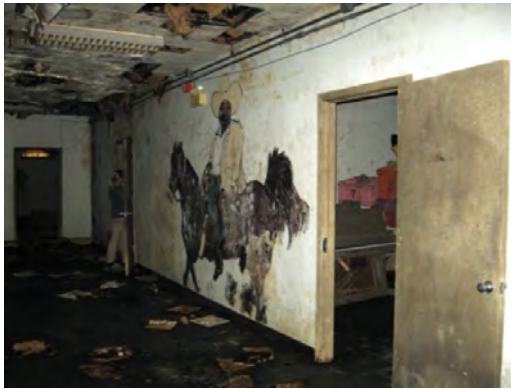
Note: **The building and site systems at the 79th Street School are damaged and deteriorated beyond economical repair throughout. The building and site are unsafe and demolition and removal of the building and site systems are needed. Estimate includes demolition and removal of the building, pavements, and other site systems. Estimates for absestos testing and abatement are also included.**

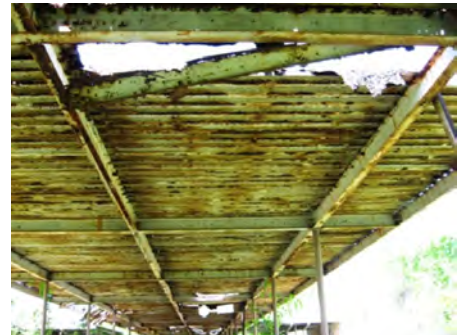
23-Apr-2010  
Covered Walkways

The covered walkways are constructed of steel columns, roof joists, and a metal deck which is covered with the remains of what appears to be built-up roof coverings. Large sections of the steel joists and roof deck have collapsed throughout the walkways making them unsafe. The walkways are damaged and deteriorated beyond economical repair. Demolition and removal of the walkways are needed and recommended.

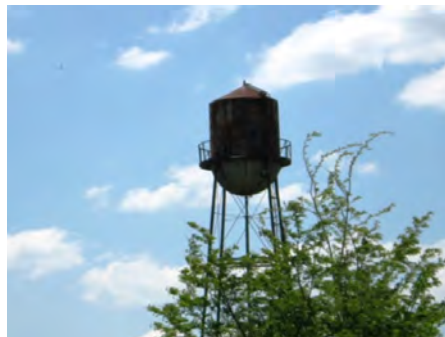
23-Apr-2010  
Water Tower

Located on the site is an elevated steel water tower. The water tower appears to be original 1958 construction and was likely a part of the school's domestic water system. The tower has been abandoned and unused for many years. The tower is damaged by severe corrosion with pitting and loss of some base metal to both the structure and tank; the tank and water systems are unserviceable. The tower and tank are damaged and deteriorated beyond economical repair and present a significant safety and liability hazard. Demolition and removal of the water tower and tank are needed and recommended.

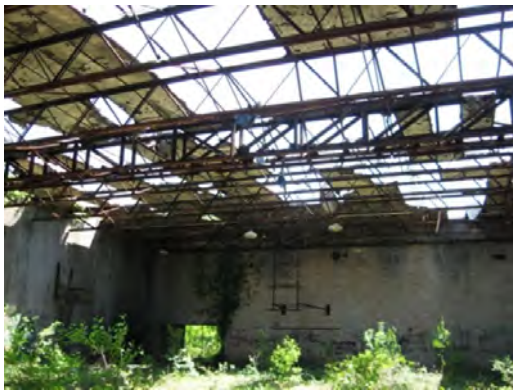
Note: **The building and site systems at the George Washihngton Carver School are damaged and deteriorated beyond economical repair throughout. The building and site are unsafe and demolition and removal of the building and site systems are needed. Estimate includes demolition and removal of the building, pavements, other site systems, and the water tower. Estimates for absestos testing and abatement are also included.**

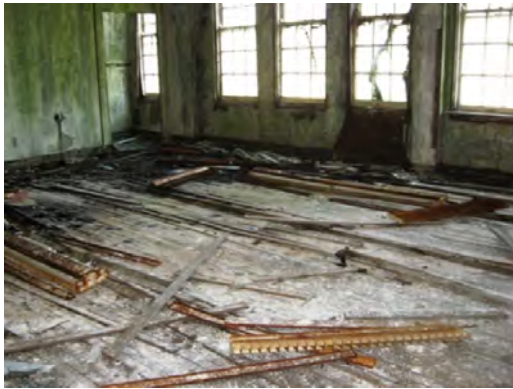
Note: **The building and site systems at the Rodessa School are damaged and deteriorated beyond economical repair throughout. The building and site are unsafe and demolition and removal of the building and site systems are needed. Estimate includes demolition and removal of the building, pavements, and other site systems. Estimates for absestos testing and abatement are also included.**

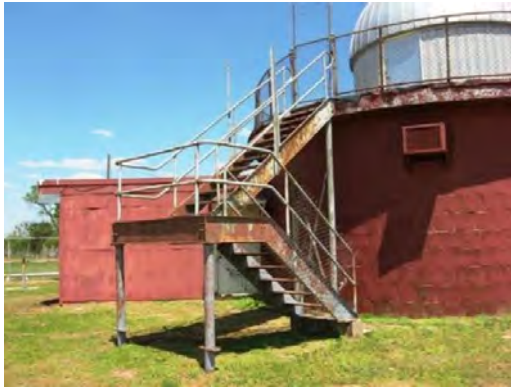
Note: **The Worley Observatory will require extensive system replacement that is not economically feasible or can be justified. The building and site systems at the Worley Observatory are obsolete, damaged and deteriorated. Due to the overall deteriorated conditions the building should not currently be used for public school purposes. This building and site present some safety and liability hazards and demolition and removal of the building and site systems should be considered.**
